BARBARA KAIM, NAZARIJ BUŁAWKA

THE SIXTH SEASON OF EXCAVATIONS AT GURUKLY DEPE, SOUTHERN TURKMENISTAN (2015)

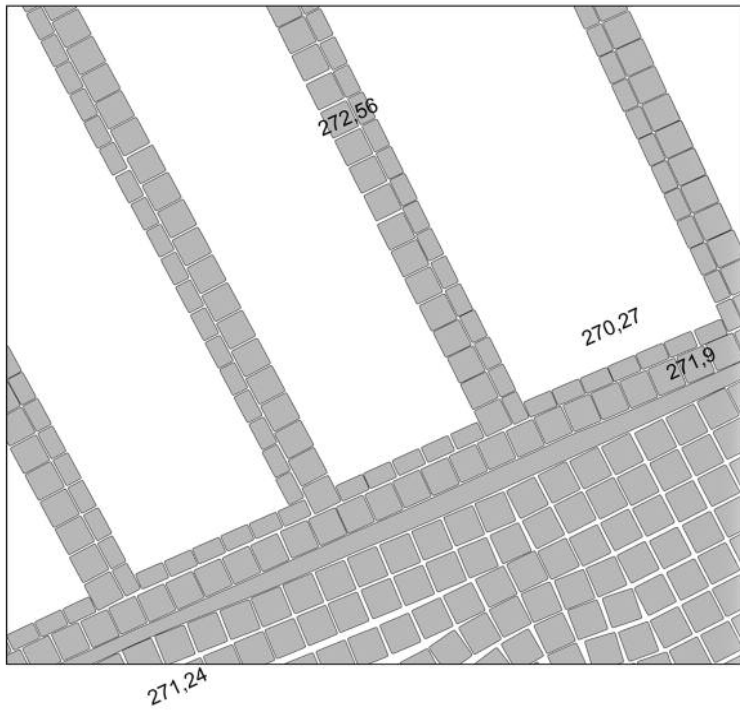
Trench 13 I

– Defensive wall

Trench 14 I

– Wall with
loopholes

– 2nd phase
of the platform

– 1st phase
of the platform

Trench 15 I

Fig. 4. Plan of trenches 13 I, 14 I, and 15 I
(drawing by N. Buławka).

However, the 2015 excavations in Trench 14 I, opened in 2014, and in the new Trench 15 I have provided some information about the earliest phase of settlement at the site of Gurukly Depe. A fragment of a solid defensive wall that once surrounded the western part of the site was exposed in Trench 14 I during the 2014 season. After the 2015 excavations, it is clear that the wall was connected with a platform (glacis), no less than 5 m high and extending ca. 10 m southwards. The only information about the way the platform was constructed is that its sloping outer face was built of mud bricks of the same size as the wall (43–44 × 43–44 × 11–13 cm). There was an outer walkway 4 to 5.5 m wide on the upper surface of the platform in front of the curtain and the tower (Fig. 4). While the size of the bricks and the form of the tower suggest that the platform and the wall may be dated to the Parthian period, too little evidence is currently available to enable more precise dating.

During the second phase, the southern part of the platform was raised by ca. 1.5 m. A new structure resembling a right trapezoid consisted of layers of brown clay,

brown clay mixed with sand, and sandy layers lined with mud bricks which created a kind of containers of similar sizes. The space between the defensive wall and this new structure was filled with river sand with scarce clods of pure clay. Adjacent to the structure and built directly on the layer of sand was a wall, one brick thick (40 × 40 × 9–10 cm), divided by projections two bricks thick. The wall was preserved up to the height of ca. 1.20 m. It was pierced at intervals by small loopholes arranged in two rows in a checkerboard pattern (Fig. 5). Because the space between this wall and the defensive wall was also filled with sand, the loopholes' function could have only been decorative.

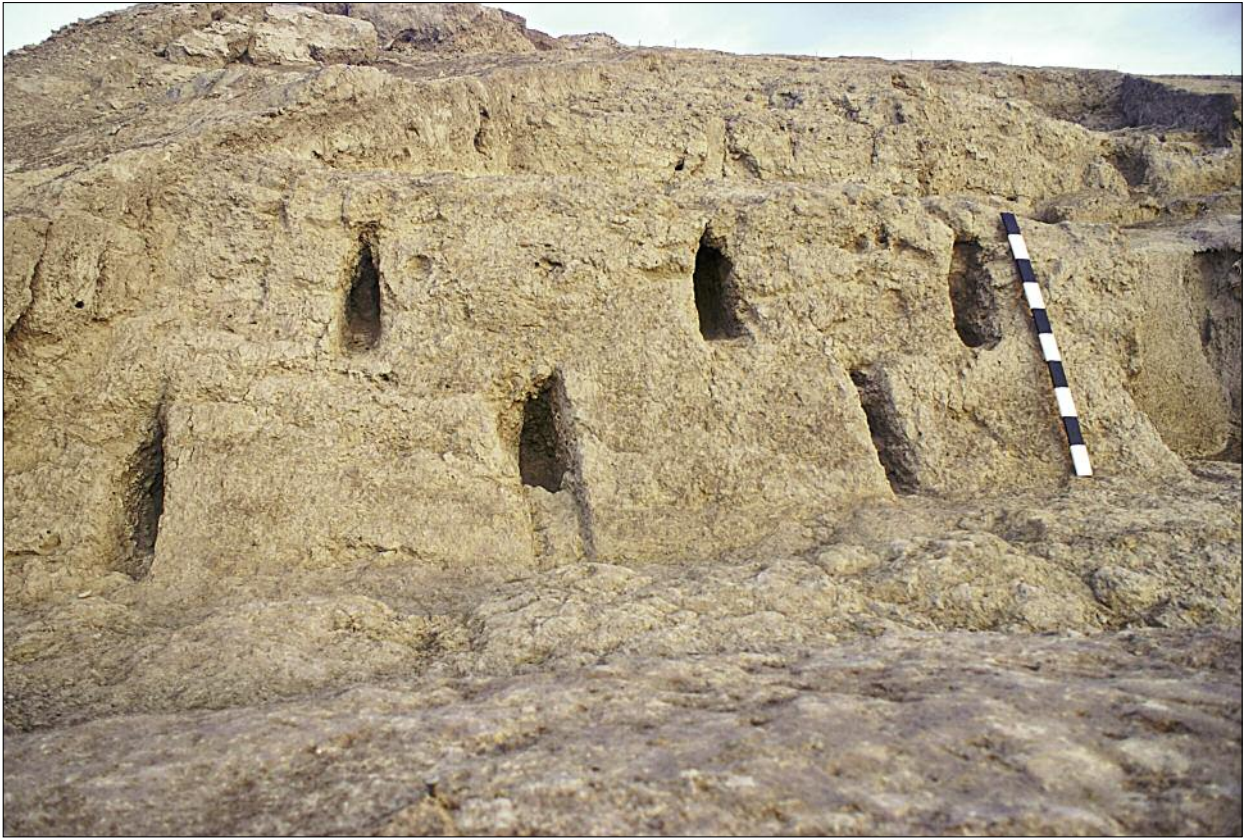
Fig. 5. Trench 14 I. Remains of a wall with loopholes (photo by B. Kaim).
